FERN LANE GREEN BUILDING ENCYCLOPEDIA

**Ecology Action Centre's
2015-2016 Renovation**

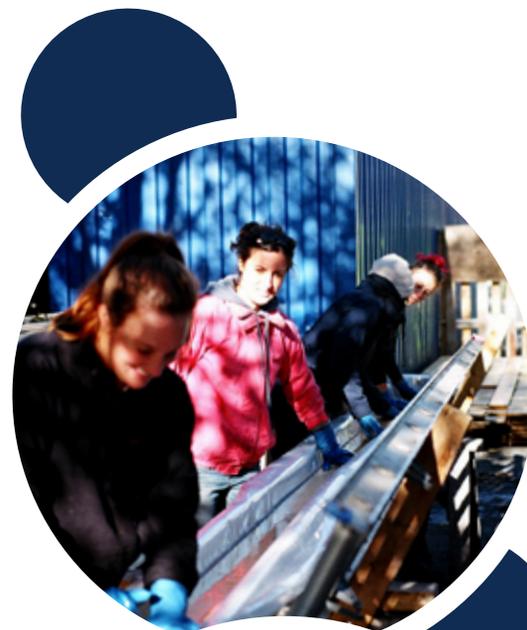
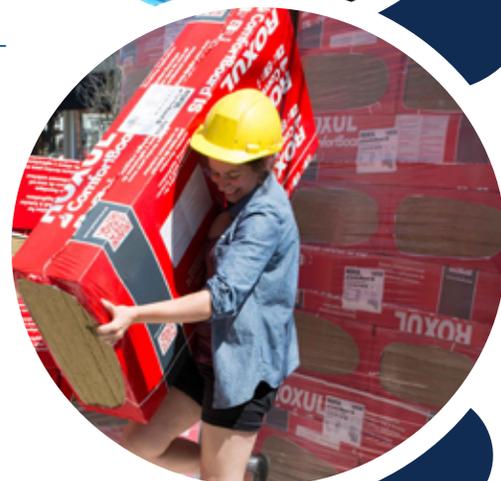
Exterior insulation (such as Roxul) was used to eliminate thermal bridging, (when heat is transferred through exposed highly conductive material). By creating a complete shell of insulation, highly conductive materials are not exposed to the exterior. There are many types of exterior insulation, of which rigid foam is most common. However, in our envelope, rigid foam might have caused moisture to be trapped inside the wall. By using Roxul, which is vapour permeable, we were able to limit the

risk of mold and decay in our walls. Ensuring that a wall can “breathe” is particularly important for renovations since the wall assembly might already include a layer that isn’t vapour permeable. Our wall was added to in such a way that any vapour which collects on either side of that layer could “breathe” either to the inside or outside of the building.

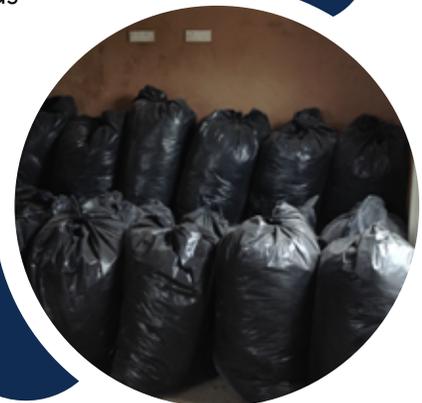
The wall cavities (primarily in the newly constructed 3rd floor) and roof were insulated with blown-in cellulose, which has an R-value of 3.5 per inch. To help reduce the need for new material we reused the cellulose that was installed as roof insulation during the 2006 renovation. Cellulose is a high value insulator. It provides low cost insulation with little environmental impact. It is composed of 75% recycled material, mainly paper and cardboard, which makes it a more sustainable alternative to fiberglass. The cellulose we used was produced in Nova Scotia by [Thermo-Cell Industries Ltd.](#) and installed by [ThermoHomes](#).

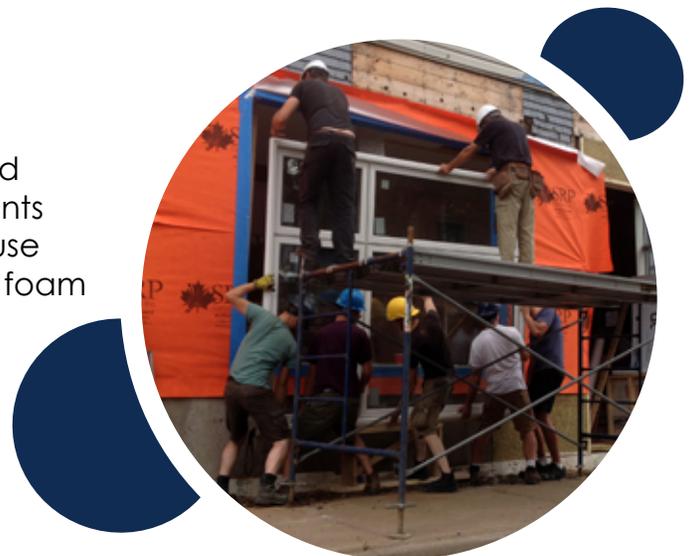
Although spray foam is an excellent insulator and air-barrier, its manufacture requires blowing agents that often utilize hydrofluorocarbon (a greenhouse gas we want to limit). As a result the use of spray foam was limited to sealing around windows.

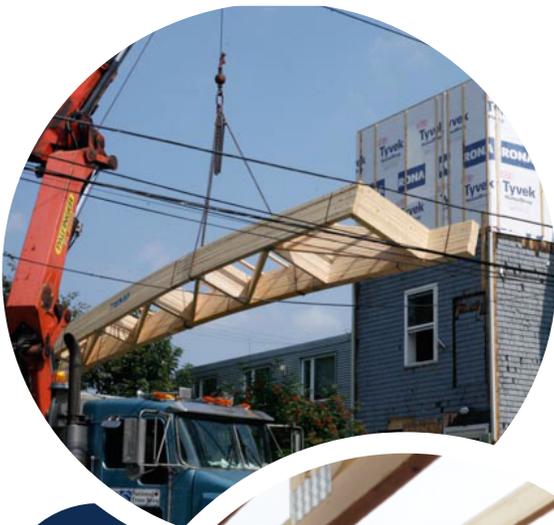
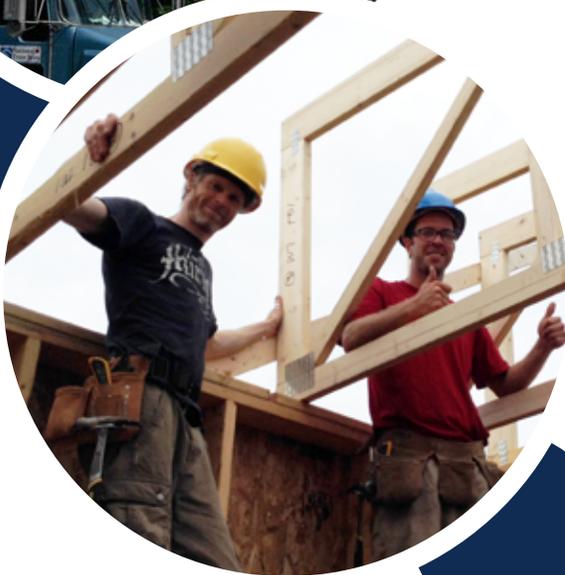
Our new roof was constructed from trusses purchased from [National Truss](#), a local company specializing in truss construction. The trusses were designed with a 30" raised heel, allowing over 24" of cellulose insulation (R-75) to be blown into the roof.

The existing roof joists were repurposed and integrated into the floor of the new third story. Conventionally, when an additional storey is added to a building the previous roof trusses are removed and floor joists added. For our project, the original roof truss system only needed slight alteration to make it an effective floor truss structure.

During the construction process, the original water-tight roof structure was maintained and the new walls and roof built on top. Once the third floor was closed in the old roof structure was removed and the third floor was connected to the building. This approach meant that the building remained water tight throughout the entire renovation.

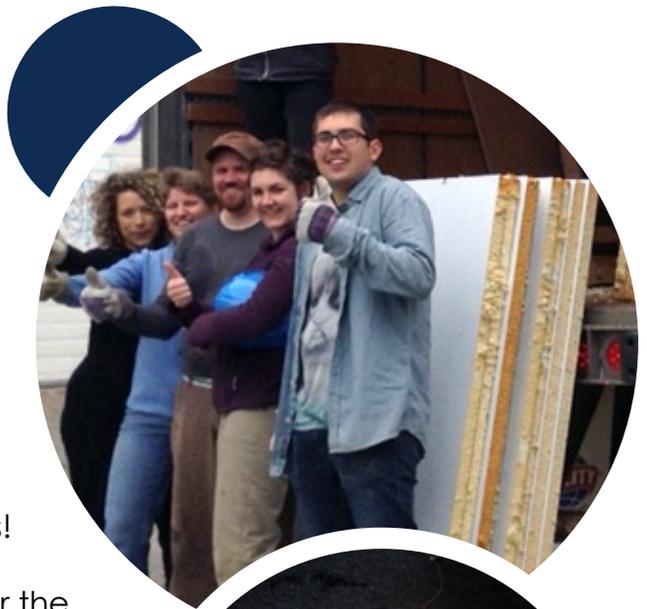
The basement floor slab was insulated with steel door cut-outs donated by [Kohler Windows and Entrance Systems](#). During the manufacturing of steel doors a complete assembly of steel and insulation is created, and then a window is cut from the assembly. The cut-outs contain excellent insulating material, that conventionally enters the waste stream. Kohler donated 400 of these cut-outs! Volunteers then assisted in removing the steel and preparing the polyurethane insulation for use under the basement subfloor. The steel was also salvaged and re-used in another Solterre Design project and at the Deanery Project.

We also salvaged material during the renovation which has been used inside the walls and below the floor. This includes the steel door cut-outs used to insulate the sub-floor, donated by Kohler Windows and Entrance Systems. This reduced the need for any new insulation, diverted material from the waste stream and showcases the dynamic potential of salvage.

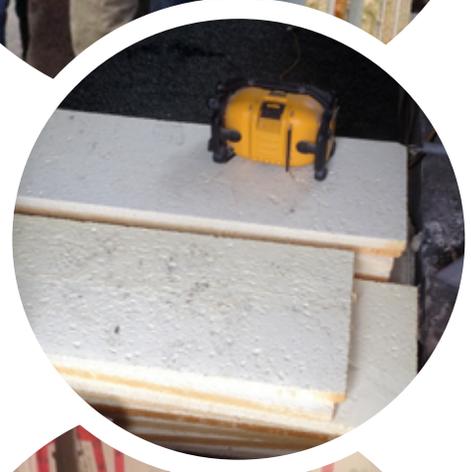
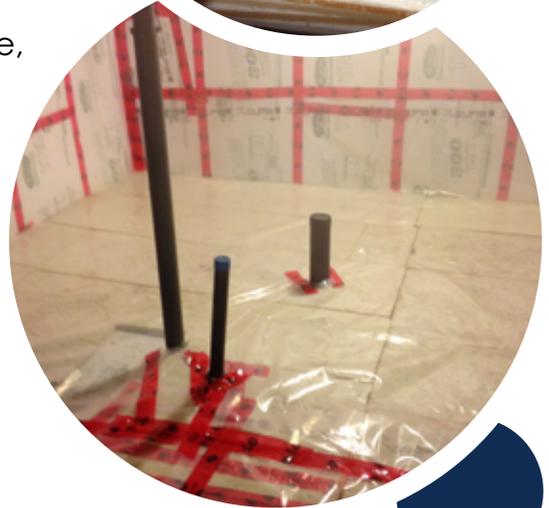
In the basement, TrueFoam 300 type 3 EPS insulation was used under the structural bearing points. This product has an R-value of 4.26 per inch. TrueFoam was also used to insulate the exterior foundation to 2 ½ feet below grade, which helps keep the building warm and protect the foundation from moisture and frost. This product does not contain dangerous fluorocarbons and, remarkably, is 100% recyclable. TrueFoam Ltd. operates an EPS densification machine which allows them to recycle Styrofoam and their own insulation products. This means scraps of TrueFoam can be returned for recycling. [TrueFoam Ltd](#) is an insulation company based in Atlantic Canada.

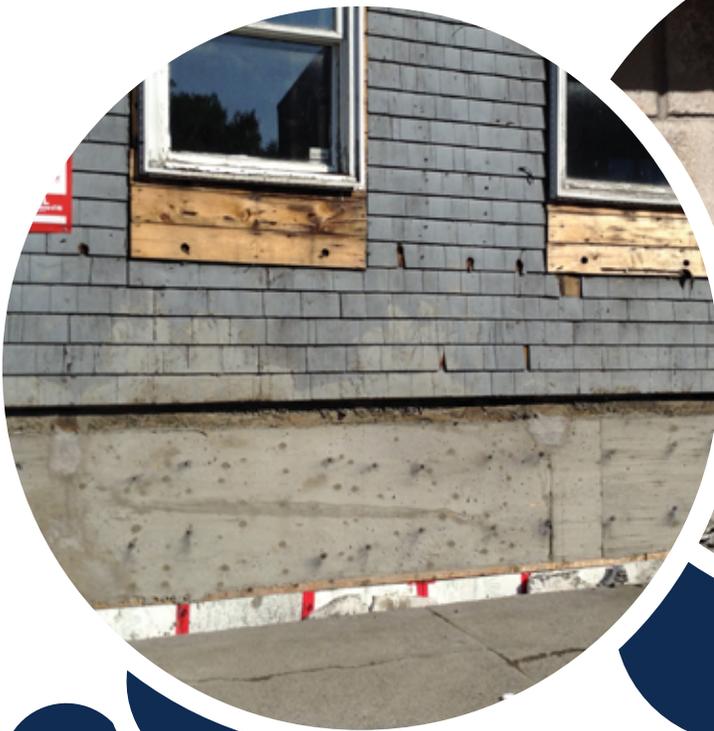
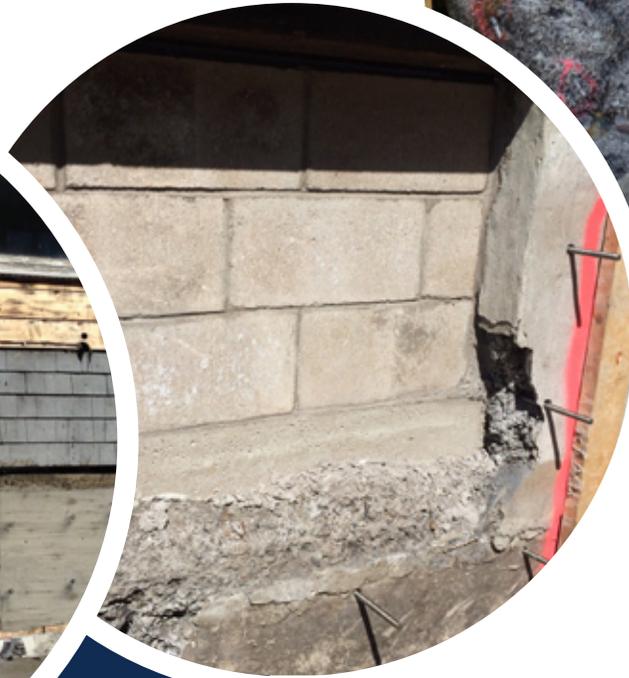
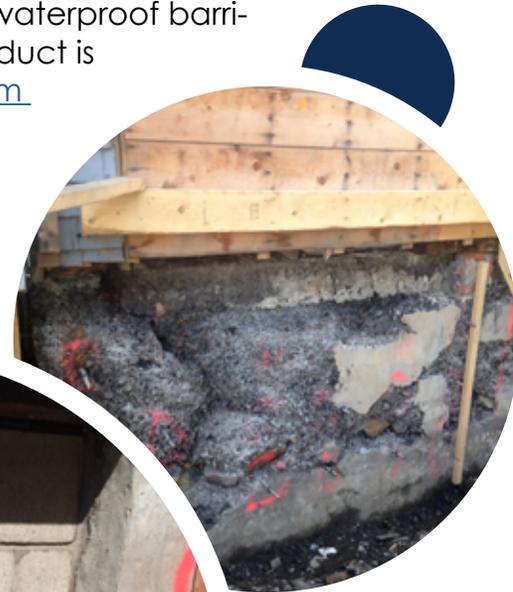
Although structurally sound, the 15" thick foundation required patching, infill and parging to repair some water damaged parts of the exterior.

[CarbonCure](#) blocks donated by [Shaw Brick](#) were used to fill in gaps where there had once been basement windows. CarbonCure is a locally based company that created a system to integrate sequestered CO₂ into concrete. The CO₂ remains in the concrete even after demolition. This innovation is particularly beneficial in the concrete industry, which is one of the world's largest CO₂ emitters.

The basement is protected by Delta-Drainage Mat which is a waterproof barrier that provides a capillary break under the insulation. The product is made by the Canadian company [Delta-MS Membrane System Ltd.](#) The mat is made of high density polyethylene, a non-toxic plastic. The drainage mat runs against the foundation and diverts any moisture into the soil below the foundation. This helps protect the building from water damage and ensure longevity.

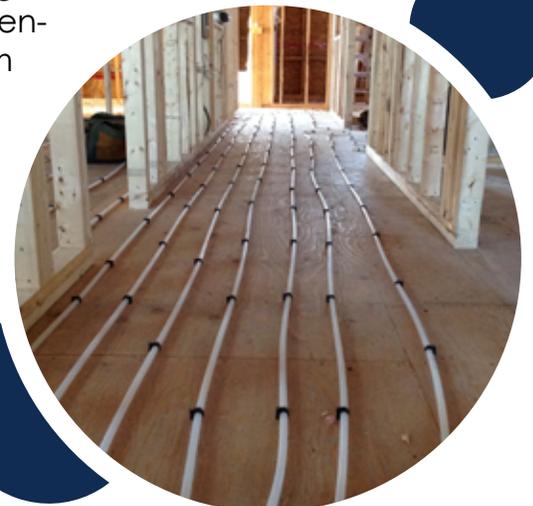
The building is heated with an in-floor radiant hot water heating system. The system features a network of plastic pipes embedded in the concrete floor. The pipes allow warm water to be pumped through the building, turning the floors into large radiators. The concrete then acts as thermal mass storing the heat through the and minimizing temperature fluctuation. One efficiency-benefit is that water does not have to be raised to a very warm temperature to effectively heat the building, since the distribution system has a large area. Secondly, since the heat is distributed throughout the building, there are fewer warm and cold pockets associated with traditional radiator systems. Finally, there is the added comfort of having warm feet, even on the coldest day.

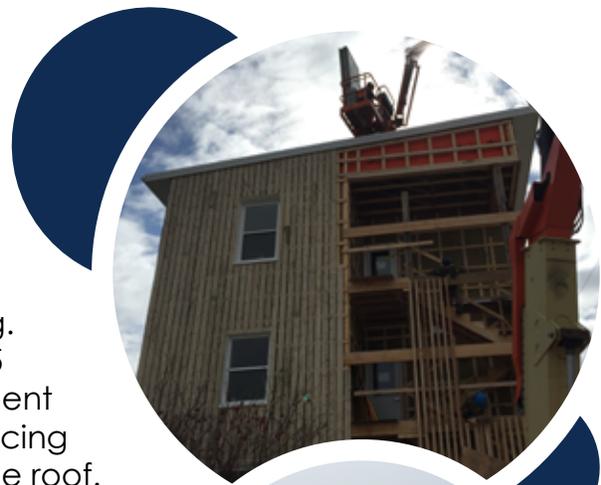
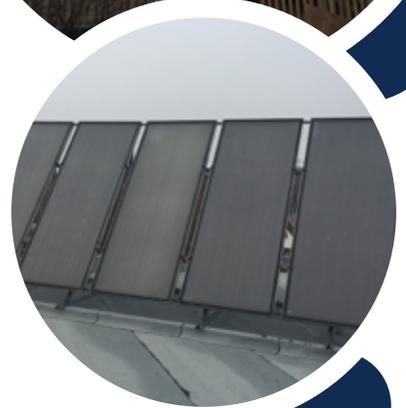
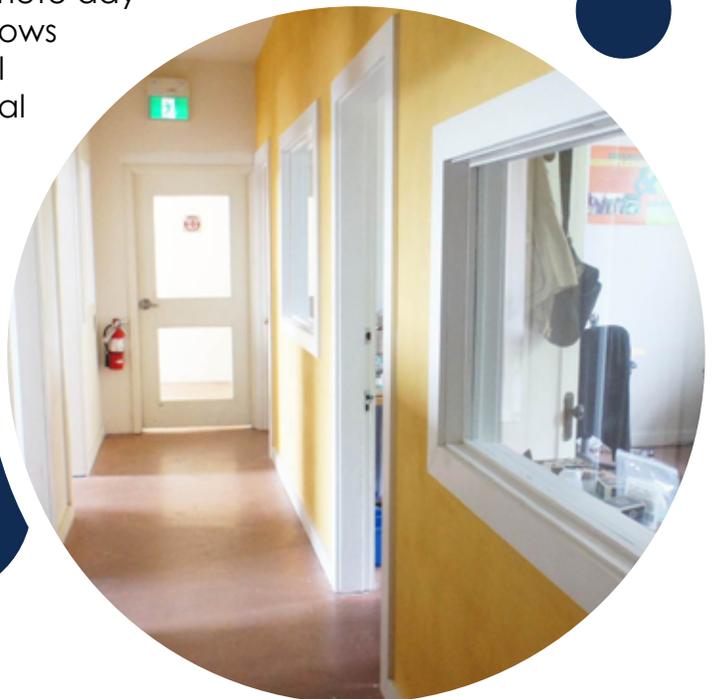
The building utilizes 10 solar thermal panels on the roof to generate hot water that is then used to heat the building. The panels were recycled and retrofitted during the 2005 renovation by [ThermoDynamic Ltd.](#), a local solar equipment company. The system includes 2 arrays of 5 south-east facing thermal solar panels, each 2' by 6' in size, attached to the roof. The panels heat a metal strip which in turn heats glycol solution (a mixture of antifreeze and water). The arrays are parallel, so that glycol only runs through one array not both. This allows the system to run more slowly, giving the glycol more time to heat up. From the roof the glycol is pumped to the basement where it runs through a heat exchanger. The cooled glycol is then pumped back to the panels and the warmed water is transferred to one of four hot water tanks where it is saved for use. To further harness solar energy a photovoltaic panel on the roof powers the glycol pump.

The system was a previously owned array purchased and originally installed by Dr. Solar in 2006. During the 2016 renovation it was reinstalled by expert volunteers with an improved orientation.
